TP 185E  
Issue 3/2014

# AVIATION SAFETY LETTER

## Bell 204 Tail Rotor Pitch Link Bolt Failure...

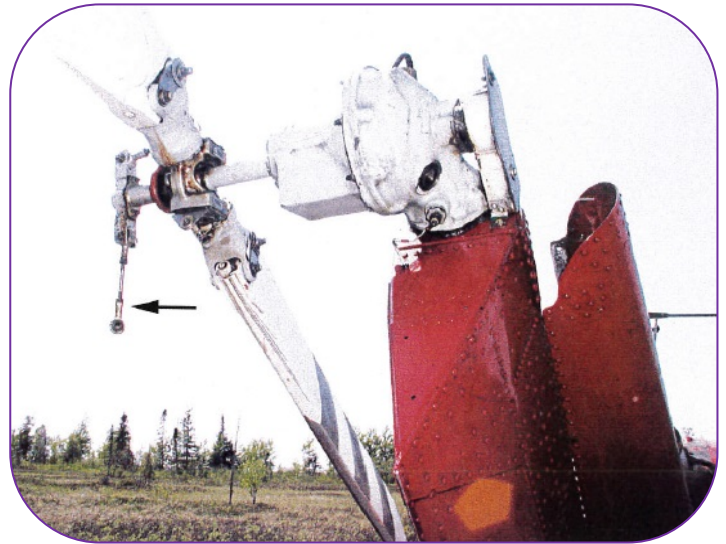
Post-flight examination revealed that one of the tail rotor pitch change link bolts was missing; the pitch change link was hanging free from the tail rotor blade grip horn (see Photo 1), but the link was still attached on the opposite end of the crosshead assembly. The disconnected tail rotor blade had struck the vertical stabilizer several times in flight, causing the banging noise heard by the pilot and the damage to the stabilizer.

*Photo 1: Detached pitch link—2003 occurrence*

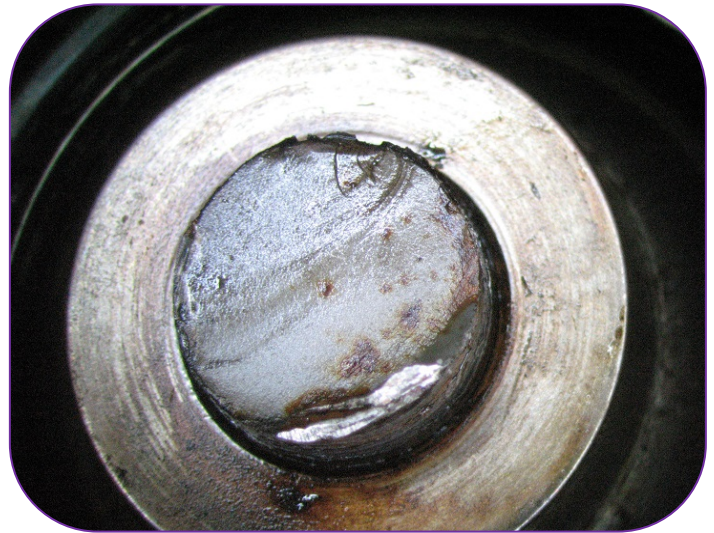
The tail rotor assembly was installed as an overhauled unit on July 7, 2002, and had accumulated approximately 211 hr of time in service. The tail rotor pitch link bolts and attachment hardware were transferred from the old tail rotor assembly to the new one at the time of installation. The pitch change link bolts are not lifed items and are controlled as on-condition items. As such, it is not known how long the bolts had been in service at the time of occurrence. Although the pitch change link bolt was not recovered, the wear pattern on the tail rotor blade grip horn pitch change bushings was indicative of an under-torqued or loose bolt arrangement.

*Photo 2: Close-up of the fractured bolt.*

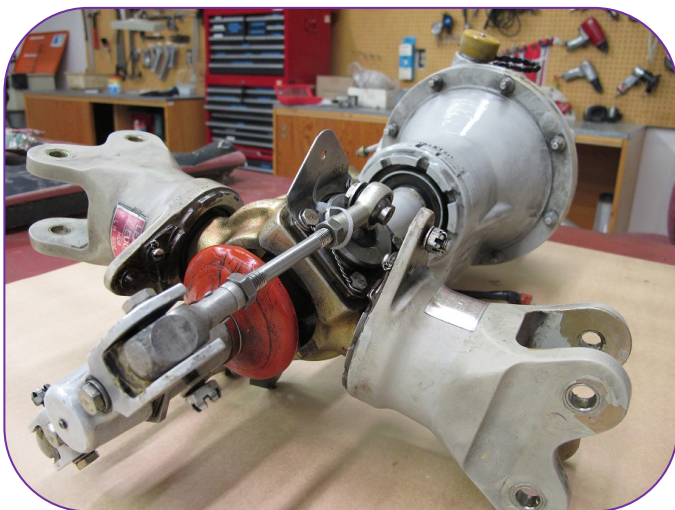
*Photo 3: Tail rotor assembly with view of the fractured bolt.*

failed. The blade had struck the side of the vertical stabilizer (pylon). Inspection of the failed bolt indicated that it had failed due to fatigue. There were indications that the bolt had been loose at some time in the past and further investigation of the damaged components indicated reverse bending damage, as would be expected in a loose bolt.

As a result of this occurrence, the operator changed their maintenance practices to ensure that the bolts are replaced at each tail rotor installation. Bolts will also be replaced if they are subsequently found to be loose during service.

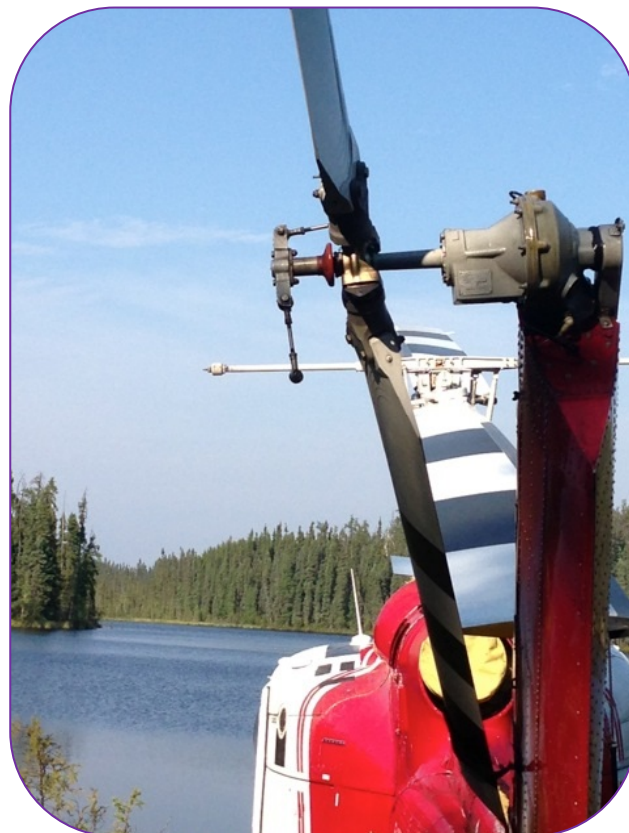
On the 2013 flight, there were a total of five people on board. The tail rotor had been installed about 45 hr prior to the occurrence. As it had been the case in the 2003 occurrence, the aircraft maintenance engineer (AME) used the existing attachment hardware. Examination of the hardware by the TSB indicated that the bolt had likely been operated, at some time previous, in a loose condition and probably already had a fatigue crack when the new tail rotor was installed. There was a step worn in both bolts (very small 0.002 in.) and there

*Photo 4: Detached pitch link—2013 occurrence*

were signs that the bolts had been rotating. The attaching washers also had recessed rings worn into them from the bolt heads and the bearing shoulders. These were the indications mentioned in the summary above.

Given the repeated occurrences and the potential serious outcome of such an event, we felt that it was important to highlight this issue. These events demonstrate the value of replacing attachment hardware at each component installation as well as replacing hardware if looseness is ever noted. △

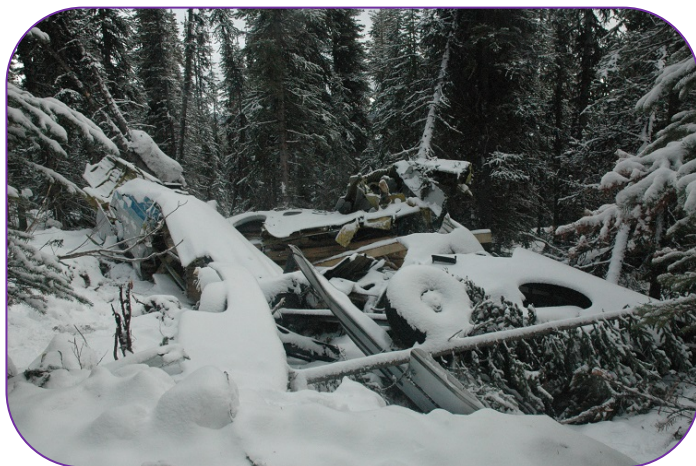
*Main wreckage site where most of the fuselage and cargo were found.*

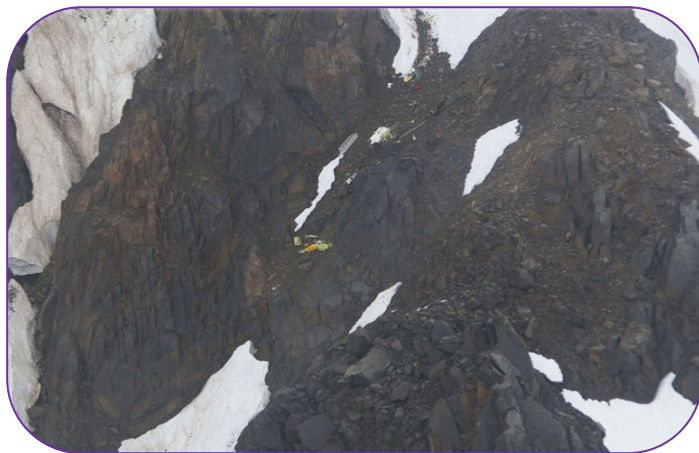
*Strewn wreckage on the steep mountain side*

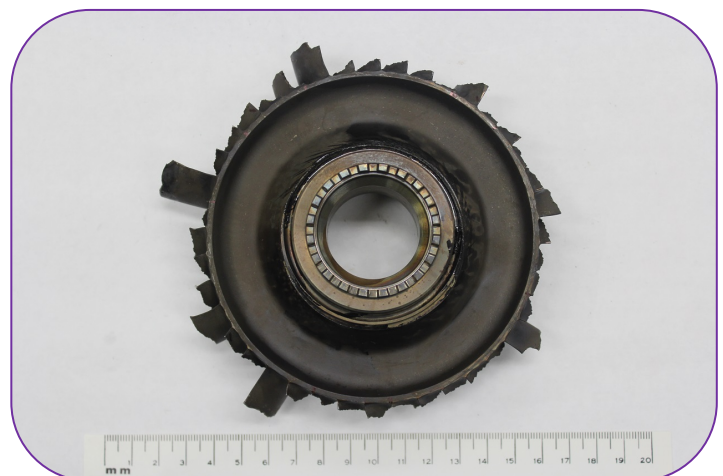
*Occurrence third-stage power turbine wheel*

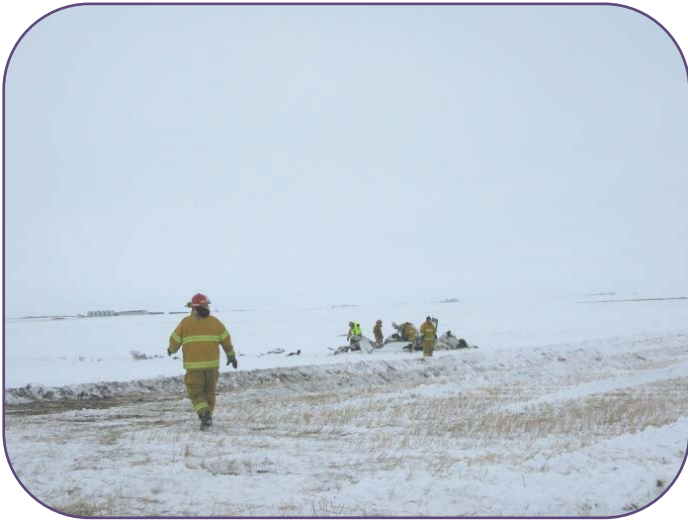
*Emergency personnel and TSB investigators at the crash site near Waskada, Manitoba. This photo of the accident site illustrates how the area was conducive to whiteout.*
