TP 185E  
Issue 3/2014

# AVIATION SAFETY LETTER

## Bell 204 Tail Rotor Pitch Link Bolt Failure...

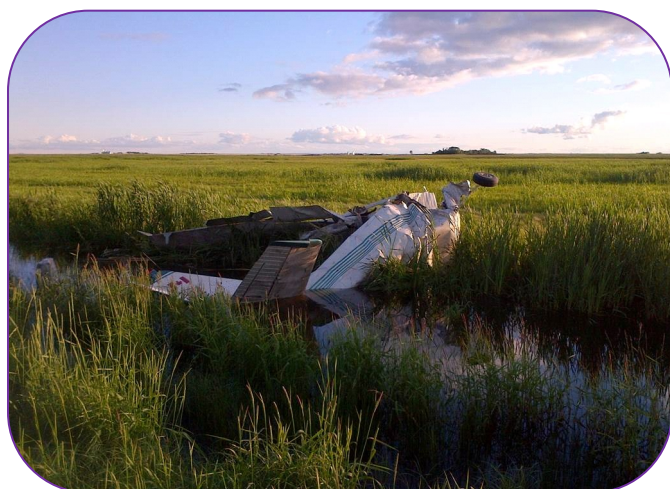
On June 15, 2014, a privately registered Cessna 172C was one of two aircraft en route from Hoffer, Sask., to an event at Lampman, Sask., with a pilot and one passenger on board. The second aircraft lost radio contact with the Cessna 172C, whose wreckage was found beside a municipal road near Torquay, Sask. The two occupants of the 172C did not survive and the aircraft was destroyed by impact forces. There was no fire.

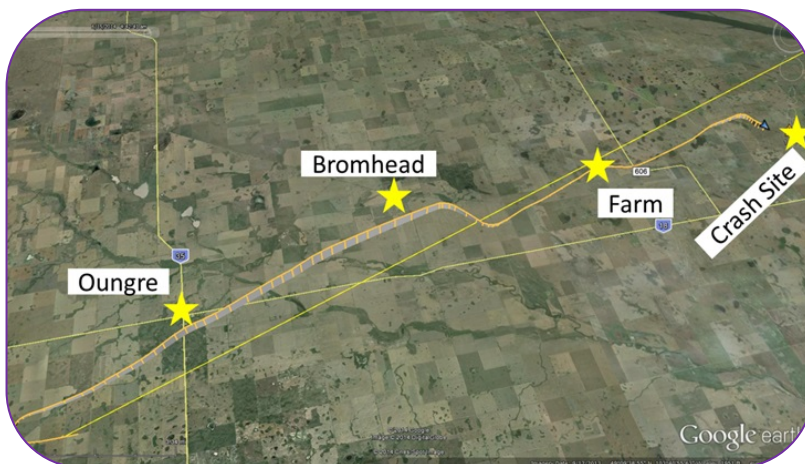
Figure 2: Cessna 172C flight path

The aircraft was equipped with a Garmin Aera 510 global positioning system (GPS), and the TSB Engineering Laboratory recovered GPS data from the accident flight (see Figure 2 for the flight path). The final GPS position recorded was about ¾ mi. before the initial point of impact.

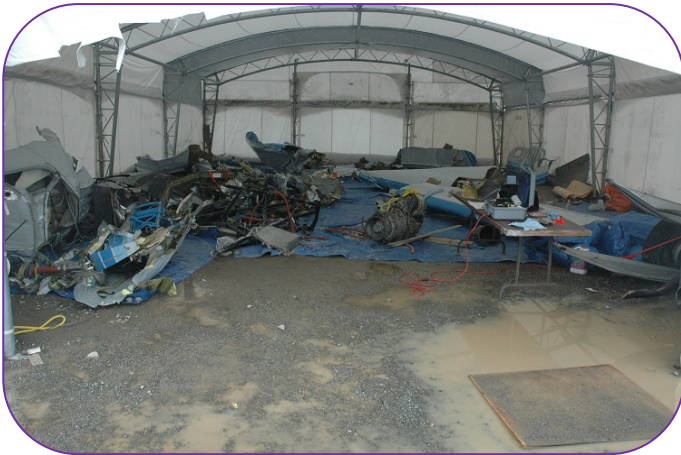
*Temporary hangar where the wreckage was recovered for initial examination, before it was moved to the TSB lab in Ottawa.*

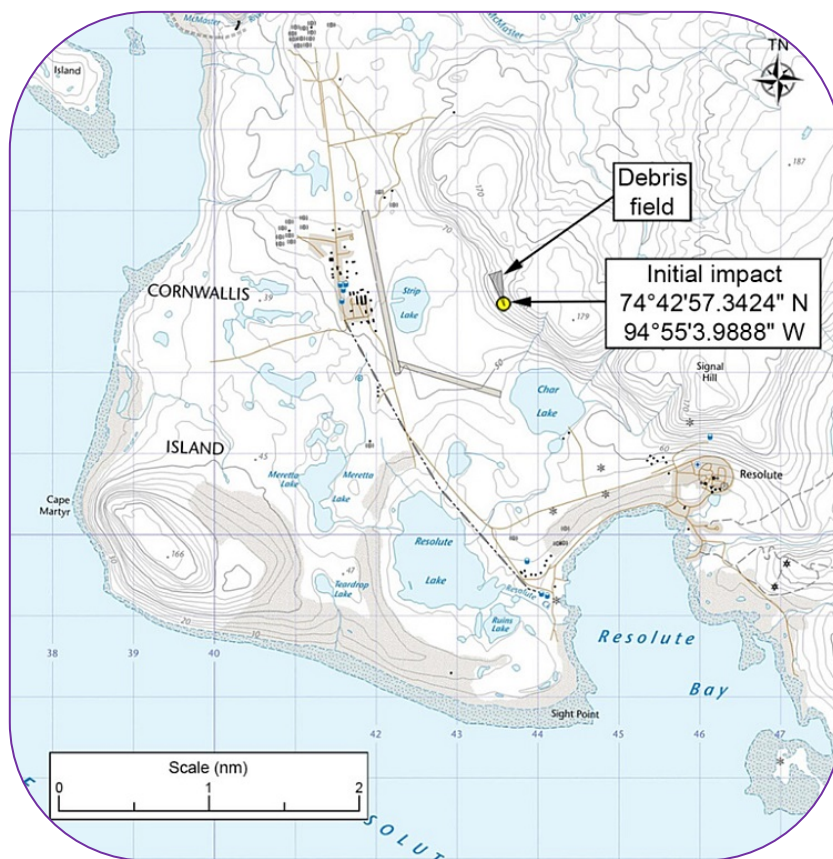
*Accident site*

On August 20, 2011, a Boeing 737-210C combi aircraft was being flown from Yellowknife, N.W.T., to Resolute Bay, Nun. At 1642 Coordinated Universal Time (1142 Central Daylight Time), during the approach to Runway 35T, the aircraft struck a hill about 1 NM east of the runway. The aircraft was destroyed by impact forces and an ensuing post-crash fire. Eight passengers and all 4 crew members sustained fatal injuries. The remaining 3 passengers sustained serious injuries and were rescued by Canadian military personnel, who were in Resolute Bay as part of a military exercise. The accident

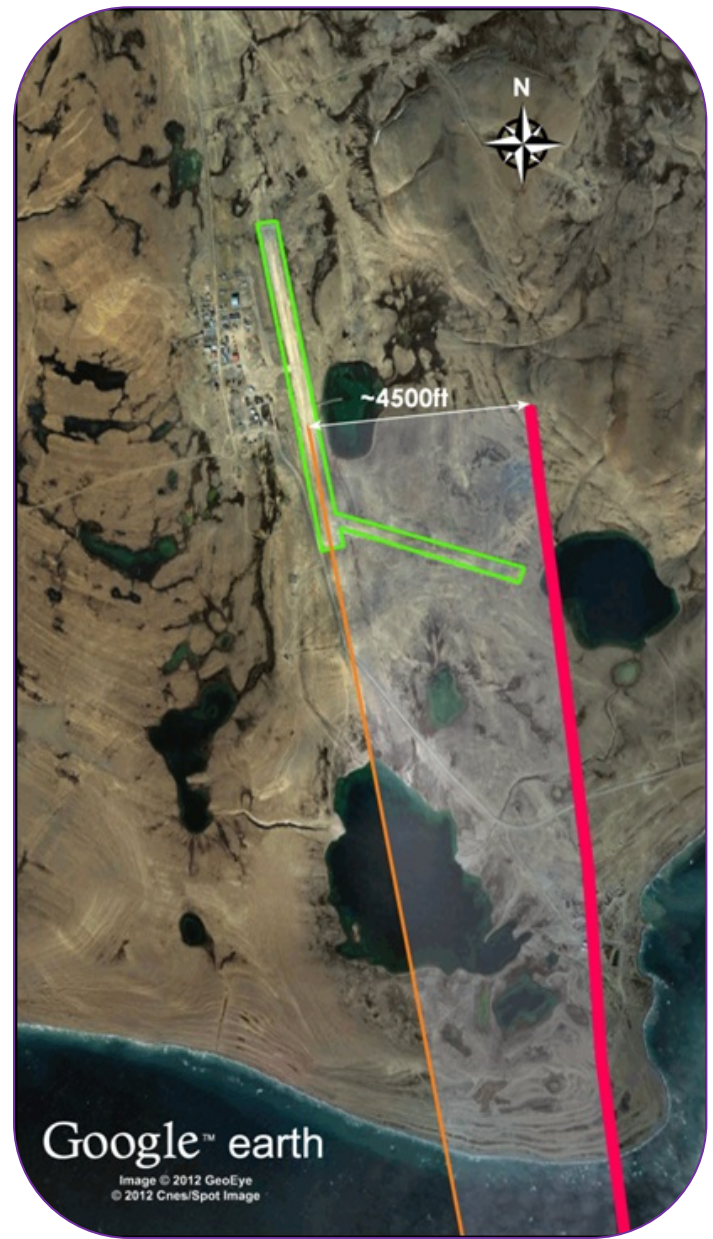
*Final approach track relative to runway  
(image: Google Earth, with annotations by TSB)*

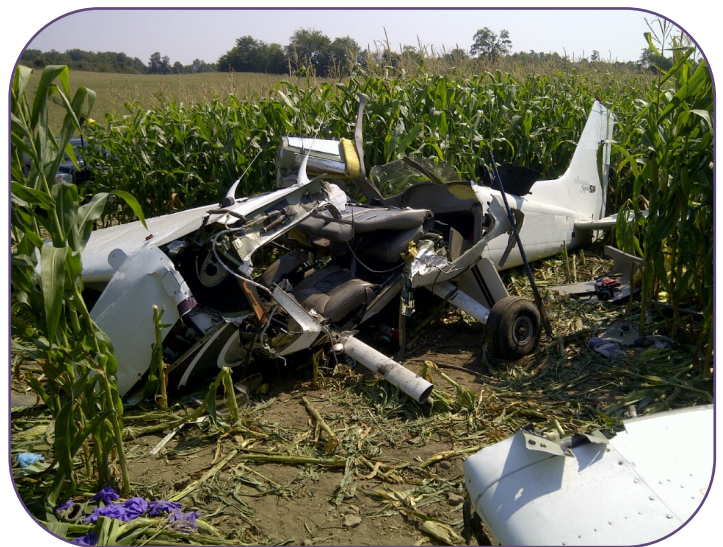
On August 24, 2012, a Cessna 172S rented from a local flying club departed the Kitchener/Waterloo Airport (CYKF), Ont., at 1815 Eastern Daylight Time, under visual meteorological conditions. The aircraft flew to Niagara Falls, Ont., then to the city of Toronto, Ont., and back to a practice area north of Kitchener Waterloo. At approximately 2016 Eastern Daylight Time, the aircraft crashed into a field, 25 NM north of CYKF. The aircraft was destroyed; the pilot and 3 passengers were fatally injured. There was no post impact fire. The emergency locator transmitter activated upon impact. *The TSB authorized the release of this report on December 18, 2013.*

The aircraft was complete and intact before the impact. There was a fracture with the stall warning system, but the effect of the fracture on the stall warning system operation could not be determined. No other abnormalities with the aircraft or its systems were discovered. The pilot was appropriately licensed, and was certified and qualified in accordance with the applicable regulations.

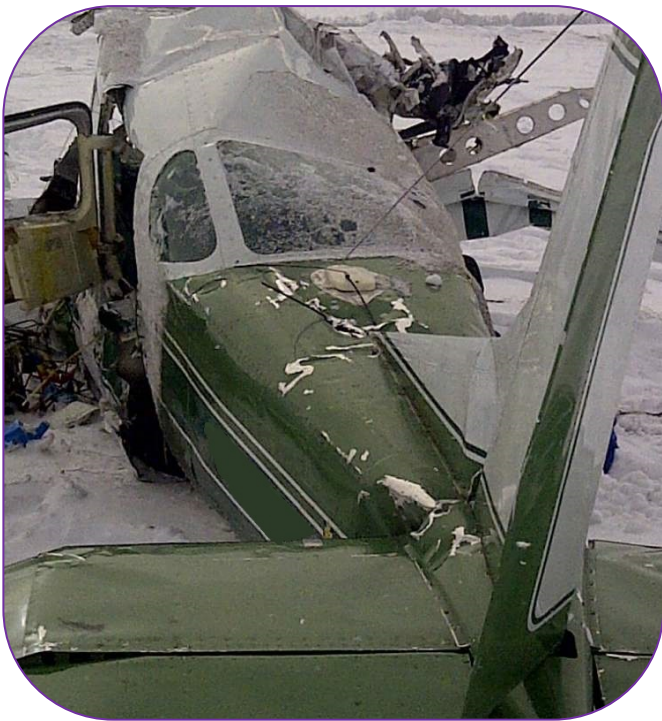
On February 10, 2013, at approximately 12:30 CST, a privately registered Cessna 210C departed a private airstrip located at Waskada, Man., with a pilot and three passengers on board for a sightseeing flight in the local area. Approximately 30 min after the aircraft departed, fog moved into the area. At 13:17 CST, an ELT signal was received in the area. A search was undertaken and the wreckage was located 3 NM north of Waskada. All occupants suffered fatal injuries. There was no post crash fire. *The TSB authorized the release of this report on January 29, 2014.*

It is therefore probable that the pilot encountered whiteout conditions and was unable to accurately judge, through visual reference, his altitude above the ground. In the absence of a visible horizon, the pilot likely experienced spatial disorientation, particularly if he initiated a turn to avoid the deteriorating weather. The pilot's lack of instrument training and experience would have made him more susceptible to the effects of whiteout and spatial disorientation.

1. The meteorological conditions in the area were conducive to whiteout.
2. The pilot likely flew inadvertently into IMC and lost situational awareness and control of the aircraft, resulting in impact with terrain.

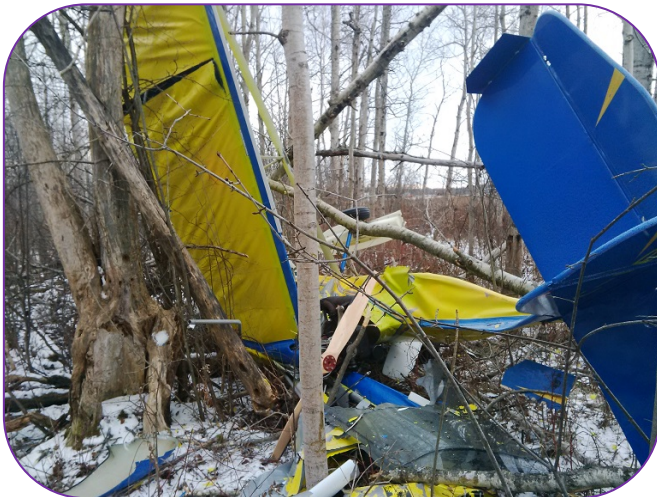
*TSB File A13O0223*

— On November 29, 2013, a **Quad City Challenger II ultralight** was completing circuits at Baldwin Airport (CPB9), Ont. During takeoff from Runway 01, while climbing through 200 ft to 300 ft, the aircraft suffered a power loss (Rotax 503) and the pilot attempted to turn right to return to the field. During this turn, the aircraft stalled and impacted the ground in a wooded area 200 m west of the departure end of the runway. The aircraft was destroyed on impact; however, the pilot, who was wearing a helmet and four-point seatbelt, suffered only minor injuries. *TSB File A13O0223*.

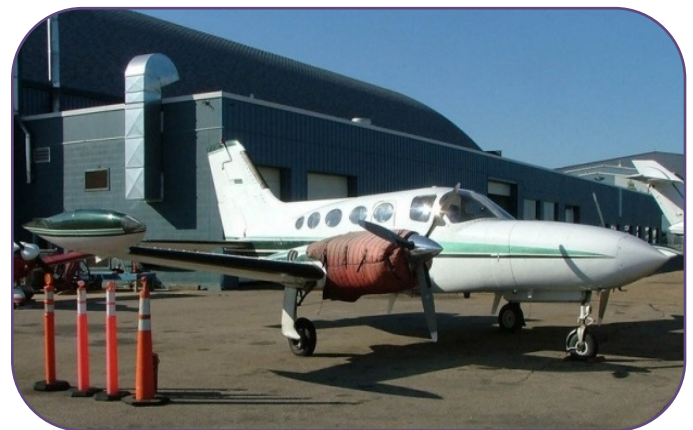
— On December 14, 2013, a **Cessna 421B**, with two persons on board, was flying IFR en route from Abbotsford, B.C., to Tofino, B.C. The aircraft was lost on ATC radar in the vicinity of Tofino. A search commenced and the aircraft wreckage was located the following morning on Vargas Island, about 11 NM northwest of Tofino Airport. Both persons on board are assumed fatally injured as the aircraft was partially buried in a marsh, and the bodies were not visible. There was no fire. *TSB File A13P0305*.

*The Cessna 421B that crashed on Vargas Island, B.C.  
(photo: Ray Barber / Airport-data.com)*

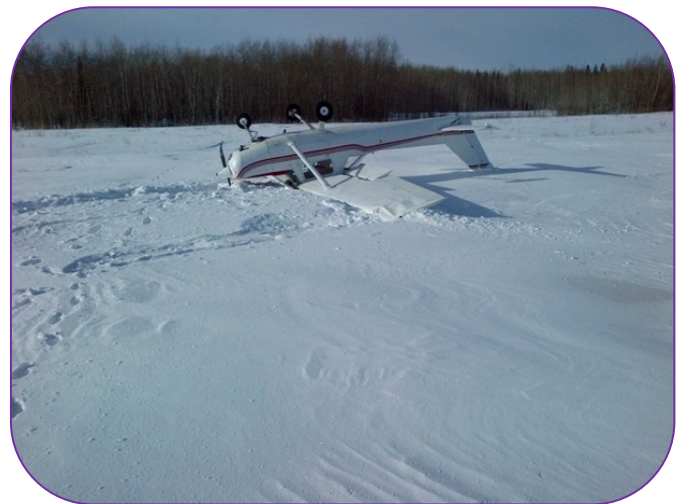
*TSB File A14C0018*

— On January 25, 2014, a **Cessna 152** was on a flight from St. Andrews, Man., to Lac du Bonnet Regional Airport (CYAX), Man. The pilot conducted a low pass to inspect the runway before landing. On touchdown, the aircraft encountered snow up to 12 in. deep. The aircraft veered left to the edge of the runway, struck a snow drift and overturned. The pilot and passenger exited without injuries. The aircraft sustained substantial damage to its wings, tail and propeller. *TSB File A14C0018.*
